Visual recovery of desert pavement surfaces following impacts from vehicle and foot traffic in the Ross Sea region of Antarctica

TANYA A. O'NEILL¹, MEGAN R. BALKS¹ and JERÓNIMO LÓPEZ-MARTÍNEZ²

Abstract: Sites of past human activity were investigated to assess the visual recovery of the desert pavement following impacts from human trampling and vehicle traffic. Visually disturbed and nearby control sites were assessed using comparative photographic records, a field-based Visual Site Assessment, and Desert Pavement Recovery Assessment. Sites included: vehicle and walking tracks at Marble Point and Taylor Valley; a campsite, experimental treading trial site, and vehicle tracks in Wright Valley; and vehicle and walking tracks at Cape Roberts. The time since last disturbance ranged from three months to over 50 years. This investigation also attempted to determine what has the greatest lasting visual impact on soil surfaces in the Ross Sea region: dispersed trafficking or track formation? Walking tracks remained visible in the landscape (due to larger clasts concentrating along track margins) long after the desert pavement surface had recovered. However, randomly dispersed footprints w

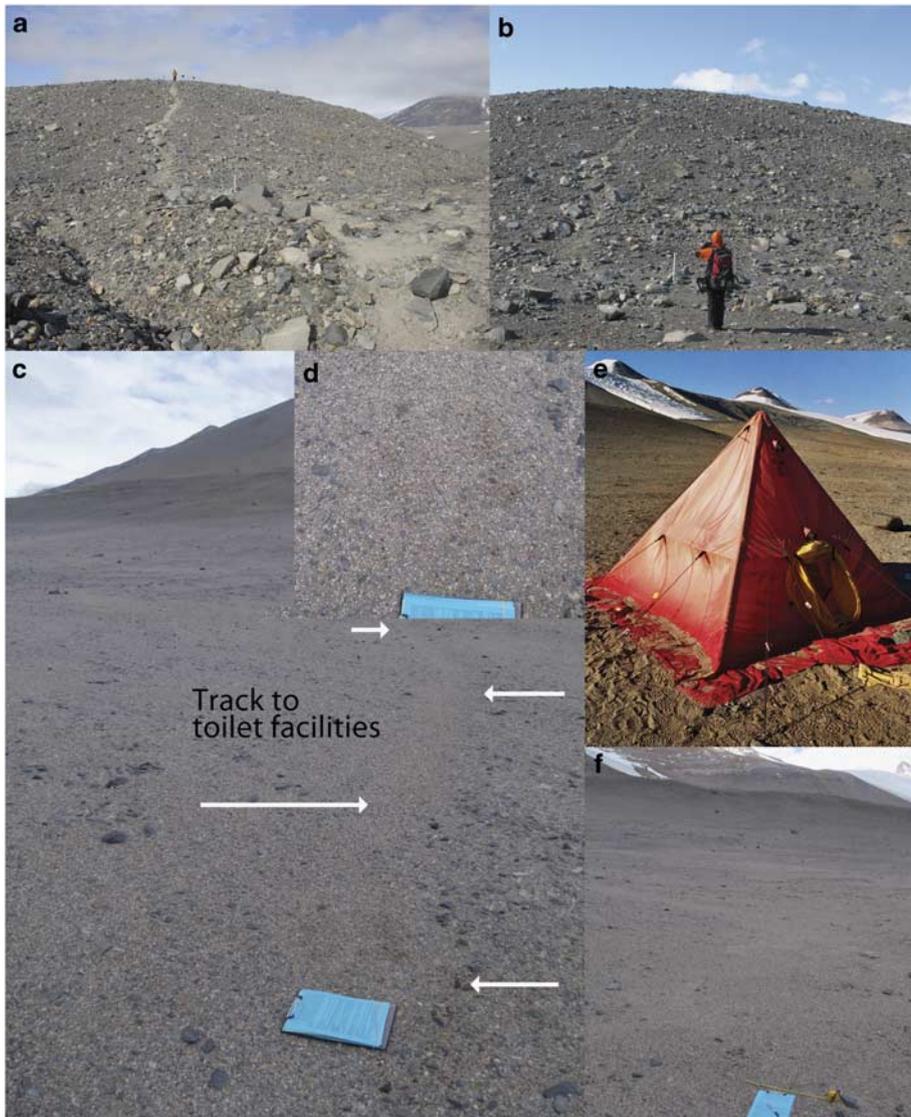
Fig. 2. Taylor Valley Visitor Zone and Loop moraine sites. **a.** Taylor Valley Visitor Zone, walking track from the helicopter landing site to the hilltop lookout, 2006/07 season, after 96 tourist visitors. Picture: Jana Newman. **b.** Walking track from the helicopter landing site to the hilltop lookout, December 2009, before first tourist group of the season. **c.** Loop moraine 2004/05 walking track to toilet, track margin visible (white arrows), after five years recovery, December 2009. **d.** Recovery of the desert pavement on the track surface, after five years. **e.** Loop moraine tent site, December 2004. Picture: Fiona Shanhun. **f.** Loop moraine tent site, five years later, December 2009.

At the Loop moraine campsite, the 2004/05 walking track between the tents and toilet facilities had abundant disturbed surface stones, and distinct surface texture change (Table IV). The ground surface had an indentation effect, the result of sorting of rock material and compaction of the inner part of the track (Fig. 2c & d). The walking track had a moderate colour contrast between the track and the adjacent undisturbed material, which is probably the result of the larger, and darker, dolerite rocks having moved to the outer margins of the track due to foot traffic (Fig. 2c). The visibly disturbed area was about 450 m² (300 m long x 1.5 m wide), and the foot track was clearly evident five years after the disturbance.

In contrast, at the Loop moraine campsite, the impacts around the tent site, caused by widespread random trampling (Fig. 2e), were undetectable (Fig. 2f). There were no visibly disturbed stones, no impressions of rocks removed, no boot imprints and no visible surface colour difference. In less than five years the desert pavement at the tent site showed visual recovery to pre-disturbance condition (Fig. 2e & f) and was visually indistinguishable

from the tent site to the toilet) would enhance the visual aesthetics by eliminating unnatural surface irregularities, and facilitate the visible recovery of previously disturbed desert pavement. Larger stones, such as those used to pin down tents at the Loop moraine campsite, must however, be replaced in original orientations with salt coated surfaces down and polished or weathered surfaces up, preferably in the indentations from which they were removed. The redistribution of disturbed rocks from vehicle and walking track margins was an effective means of remediation at the former Vanda station site (MRI of 90%), but needs to be undertaken with an understanding of the rock material's natural position in the environment.

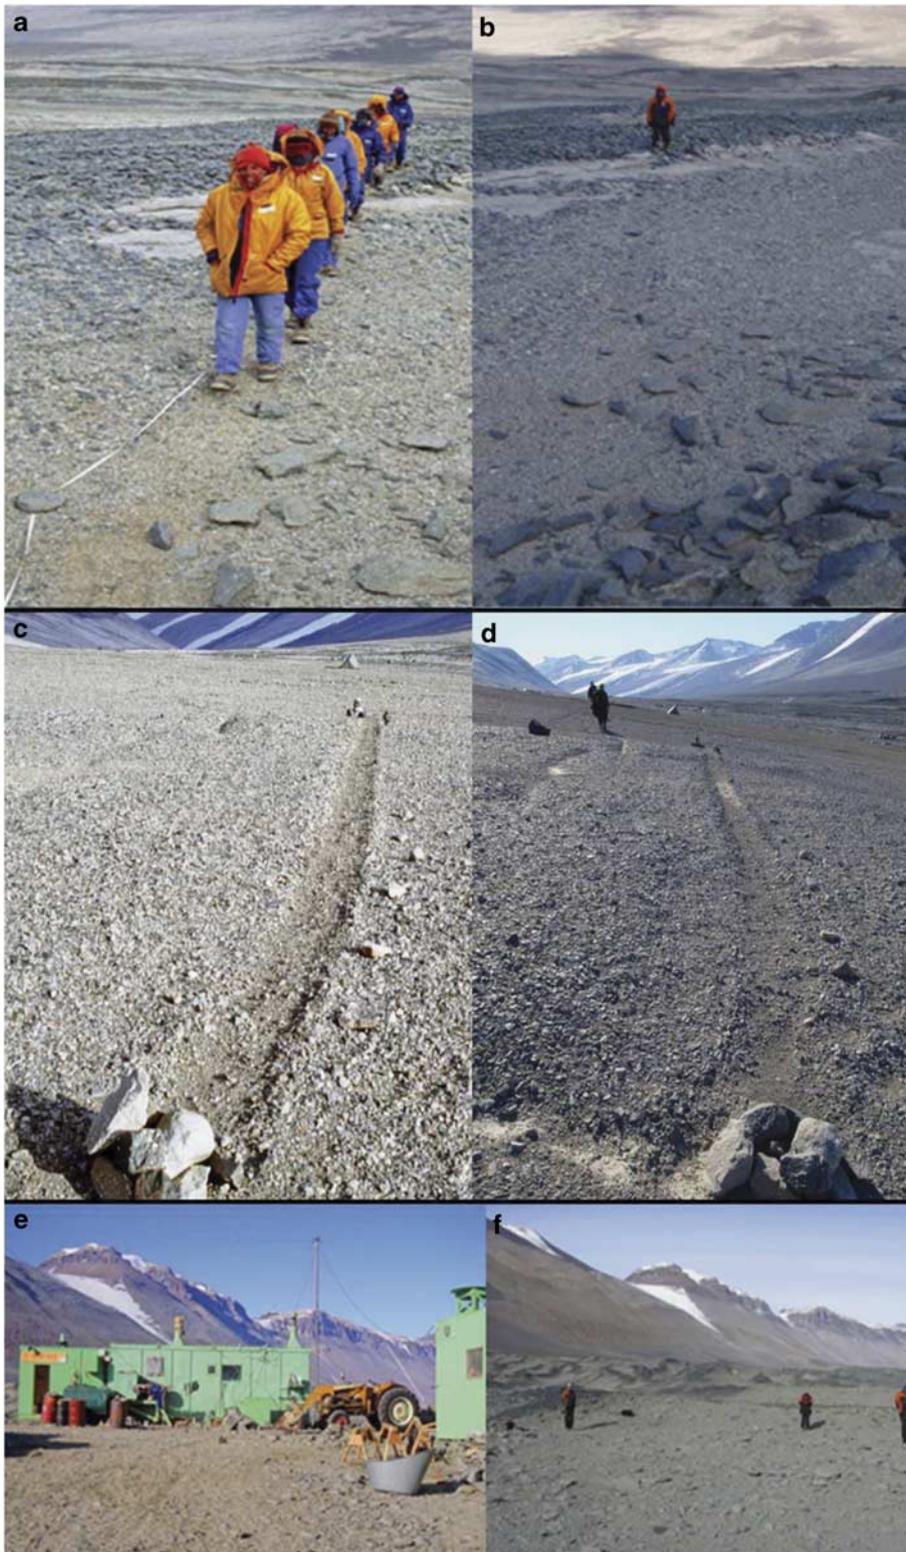
Fig. 3. Vanda experimental treading trial and former Vanda station sites. **a.** “Vanda Rocky” site, 192 passes, December 1993. **b.** “Vanda Rocky” site, after 17 years of recovery, December 2009. Note the “out of place” stones that were used to secure the measuring tape in December 1993. **c.** “Vanda Fan” site, immediately after 200 passes, December 1993. **d.** “Vanda Fan” site, after 17 years of recovery, December 2009. **e.** Vanda station, January 1992, immediately prior to removal. **f.** Site of the former Vanda station mess hut, December 2009. The three people are marking the corners of the former buildings.

Most impacts at the “Vanda Rocky” experimental treading site were minimal or non-existent (Fig. 3a & b). Only the “softer” mixed till sections, between the slabs of coarser granodiorite bedrock, showed traces of the track (Fig. 3b). There were some unnaturally positioned bedrock slabs lining the middle of the track which had been placed there to hold the measuring tape during the experiment. There were no impressions of removed rocks, no boot imprints, or salt deposits on the surface of the “Vanda Fan” and “Vanda Rocky” treading trial sites (Table IV). In contrast, the experimental walking track on the “Vanda Fan” site, formed on an alluvial fan comprising soft mixed till materials, remained an obvious feature in the landscape 17 years after the treading trial experiment (Fig. 3c & d). The “Vanda Fan” site had an abundance of disturbed surface stones, obvious stratigraphic disturbance, and a moderate surface colour contrast (Table IV). Whilst the desert pavement of the inner part of the track had partially recovered, the larger clasts which were once scattered

across the entire ground surface were concentrated along the margins of the walking track and the associated indentations persisted in the landscape (Fig. 3d). The “Vanda Fan” site was in an intermediate stage of visual desert pavement recovery (MRI of 62%), whilst the “Vanda Rocky” site, which had higher cobble to sand fraction and greater resistance to the original trampling impacts, was in an advanced stage of desert pavement recovery (MRI of 96%) (Table V). The visibly disturbed area of the “Vanda Fan” site was 20 m², with 6 m² at the “Vanda Rocky” site.

observed at the surface at the time of investigation were exposed by the same winnowing processes that rehabilitate the desert pavement. Clasts were less embedded and there was a greater proportion of smaller rock fragments at the former station site compared with the control site. The site of the former Vanda station had a MRI of 90% (Table V), indicating the desert pavement is in an advanced stage of rehabilitation.

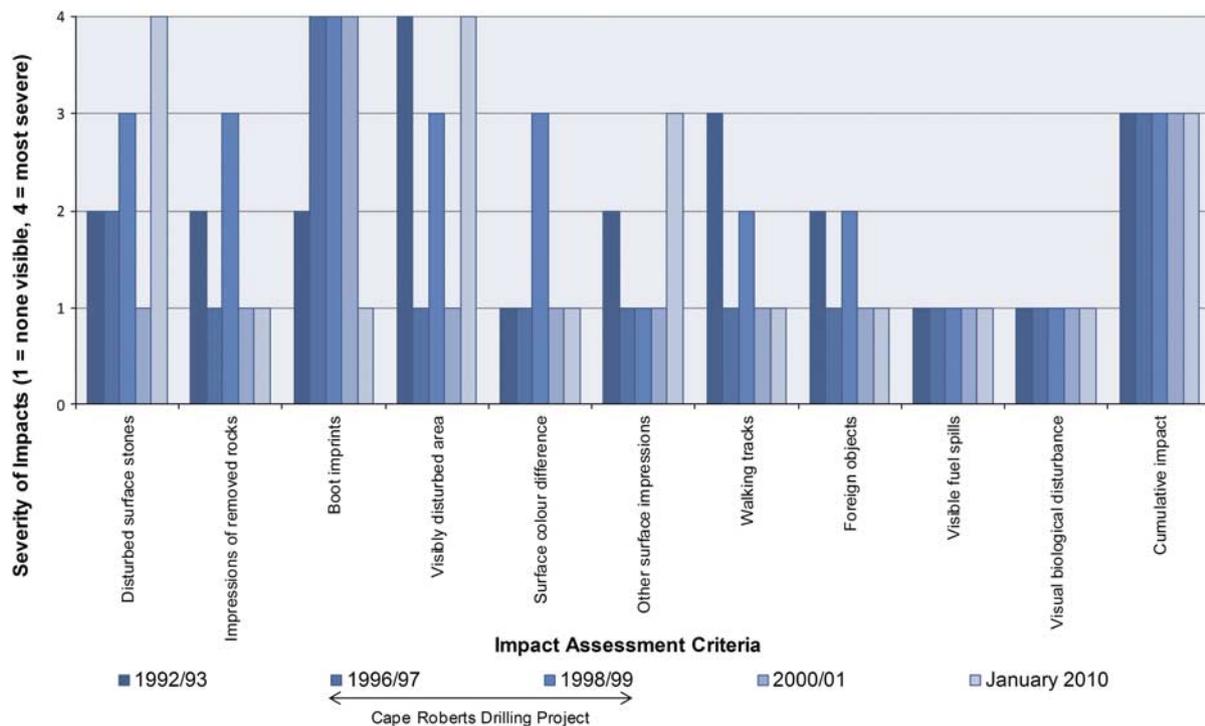
Fig. 4. Visual Site Assessment of Cape Roberts Project (CRP) “Northern Plot” monitoring site, pre-CRP (1992/93, after Campbell & Keys 1993), during CRP (1996/97 and 1998/99, after Waterhouse 2001), after remediation (2000/01, after Cowie 2001), and ten years after remediation (January 2010). Note: January 2010 control scores are not shown, however, each impact assessment criteria scored a one.

At the “Northern Plot” VSAs showed the site was overall in better condition in 2010 than in the pre-CRP baseline assessment in 1992/93 (Fig. 4). This probably reflects effective site cleanup and restoration in 1999/2000 and 2000/01. The Cape Roberts sites had been disturbed on numerous occasions prior to the commencement of the Cape Roberts Drilling Project. In 2010 there was an improvement in four impact assessment criteria, including, a decrease in impressions of removed rocks, boot imprints, presence of foreign objects, and evidence of formed walking tracks. Four criteria remained the same, and the evidence of cumulative impact remained consistent at $> 100 \text{ m}^2$. Mid-project 1996/97 and 1998/99 VSAs showed an increase in impressions of removed rocks, evidence of walking tracks, and foreign objects over the duration of the drilling project. The abundance of disturbed surface stones, and other surface impressions, shows only partial recovery to baseline 1992/93 condition (Fig. 4), with rehabilitation probably an ongoing process. The “Northern Plot” had an MRI of 88% (Table V).

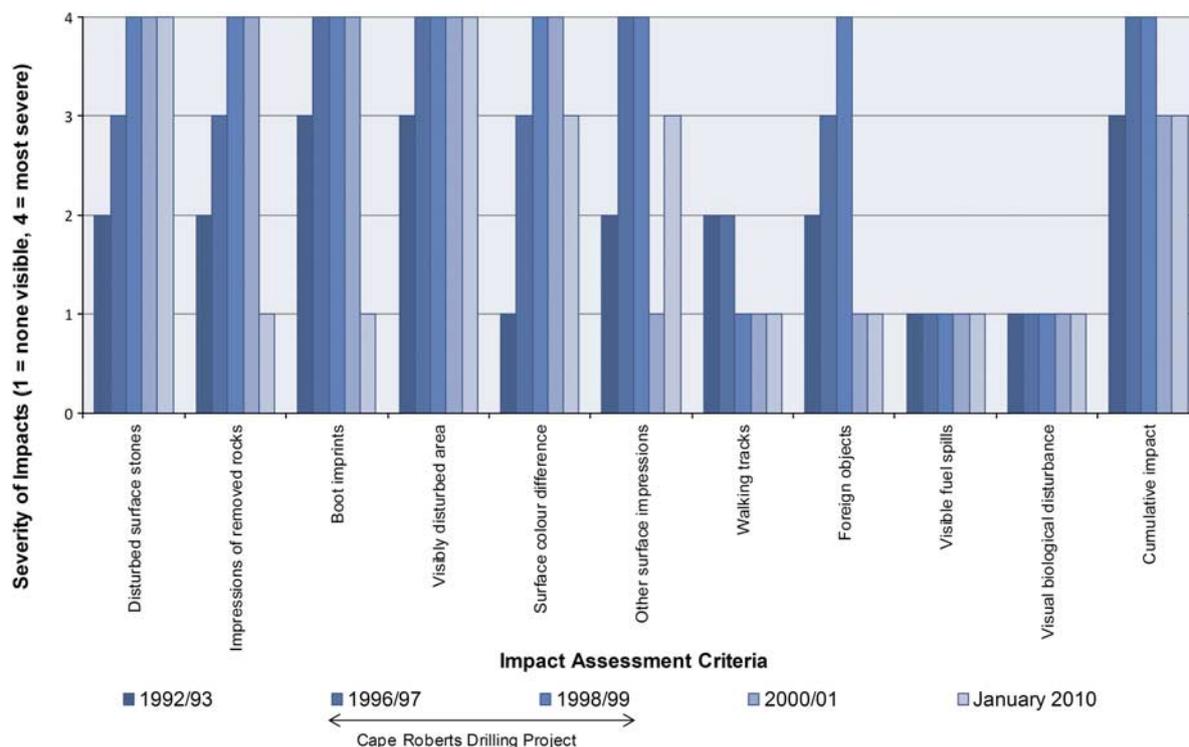
Fig. 5. Visual Site Assessment of Cape Roberts Project (CRP) “Southern Plot” monitoring site, pre-CRP (1992/93, after Campbell & Keys 1993), during CRP (1996/97 and 1998/99, after Waterhouse 2001), after remediation (2000/01, after Cowie 2001), and ten years after remediation (January 2010). Note: January 2010 control scores are not shown, however, each impact assessment criteria scored a one.

Visual impacts were consistently greater at the “Southern Plot” as it was the site where most vehicle and walking tracks were concentrated, and the location of the fuel rack and huts. The “Southern Plot” showed deterioration in some of the criteria re-assessed in 2010. There was a decline in four impact assessment criteria, including an increase in abundance of disturbed surface stones, and visibly disturbed areas, and evidence of other surface impressions, such as Hagglund vehicles tracks and helicopter skid marks (Fig. 5). Three impact assessment criteria remained the same, such as the extent of cumulative impact which remained consistent at $> 100 \text{ m}^2$, and four showed an improvement beyond the 1992/93 baseline assessment (impressions of removed rocks, boot imprints, evidence of walking tracks, and foreign objects). The surface colour contrast between the impacted site and the surrounding undisturbed material showed the greatest increase in the first few years of the project. Both the visibly disturbed area and cumulative impacts increased rapidly at the beginning of the CRP (see 1996/97 and 1998/99 VSAs, Fig. 5), and remained “severe” over the duration of the project. The 2010 assessment showed no obvious evidence of post-CRP environmental monitoring soil sampling pits, nor visible evidence of the removal of contaminated sand and gravel that was taken during remediation (Waterhouse 2001).
